PHASE 2 ENVIRONMENTAL SITE ASSESSMENT
Maersk Pacific Limited
Building 600
Tacoma, Washington

JN 00026E

Subject: **Phase 2 Environmental Site Assessment**
Maersk Pacific Limited
Building 600
Tacoma, Washington

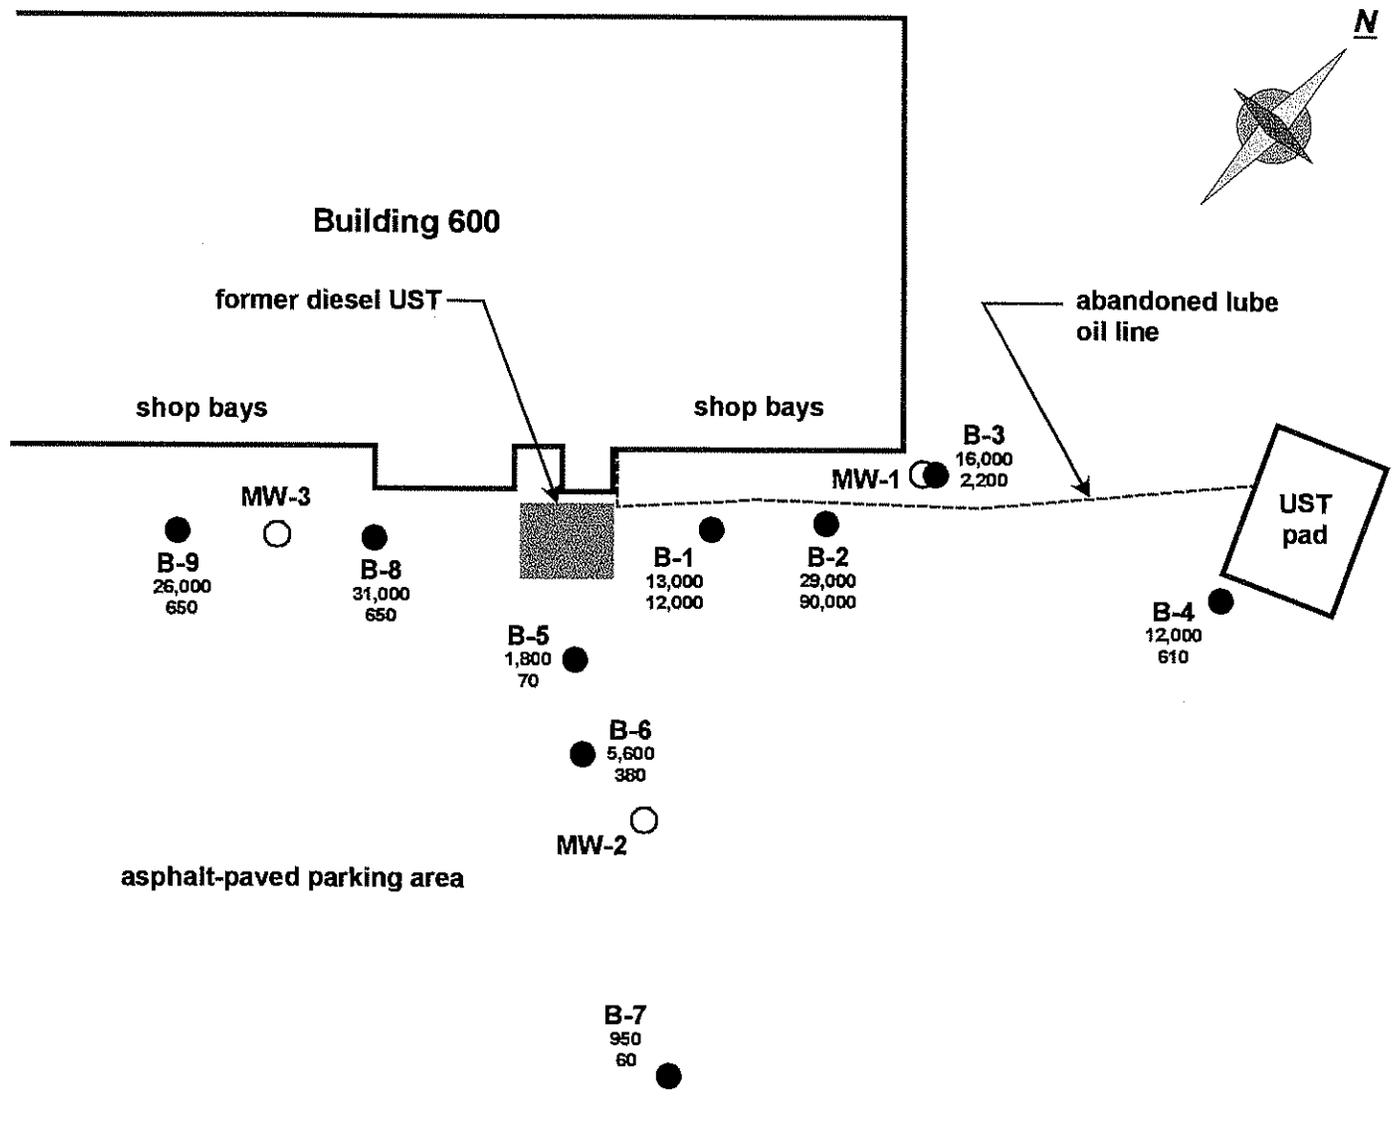
SAMPLING LOCATION MAP
 Maersk Pacific Limited
 Tacoma, Washington

The locations of the test borings and monitoring wells are illustrated on the Sampling Location Map, Plate 2. In general, the subsurface soil in the borings consisted of dark gray, slightly silty, fine- to medium-grained sand underlain by a gray, sandy silt. In some locations, this was underlain by a gray, silty sand. Obvious signs of petroleum contamination (odors, sheen, etc.) were observed in many of the borings. The boring logs, appended as Plates 4 through 12, give greater detail on the specific conditions encountered at each drilling location. Groundwater was encountered during drilling at approximately 10 feet below the ground surface (bgs) in each of the borings.

former diesel UST

abandoned lube oil line

Inferred Direction of Shallow Groundwater Flow

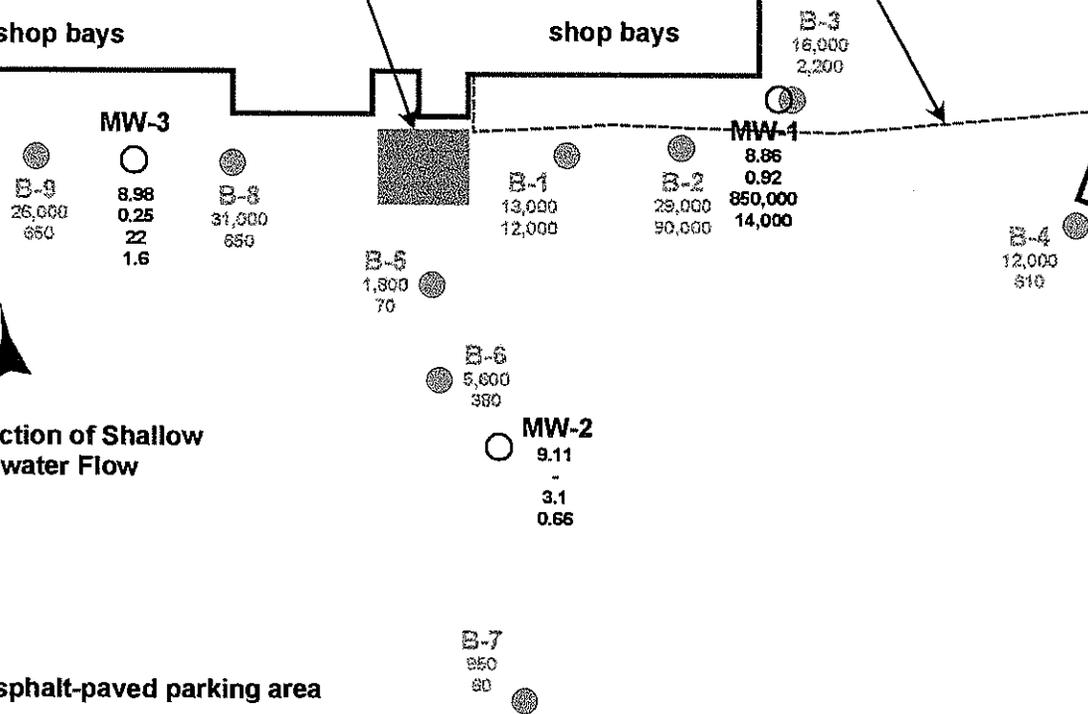
GROUNDWATER DATA MAP
 Maersk Pacific Limited
 Tacoma, Washington

Free product was found in Monitoring Wells 1 and 3.

The water table elevations suggest that the direction of groundwater flow at that time of the survey was toward the north-northwest. Tidal influences may affect the direction of groundwater flow and the distribution of contaminants.

8.98 groundwater elevation
 0.25 thickness of free product, ft.
 22 diesel-range petroleum, ppm
 1.6 oil-range petroleum, ppm

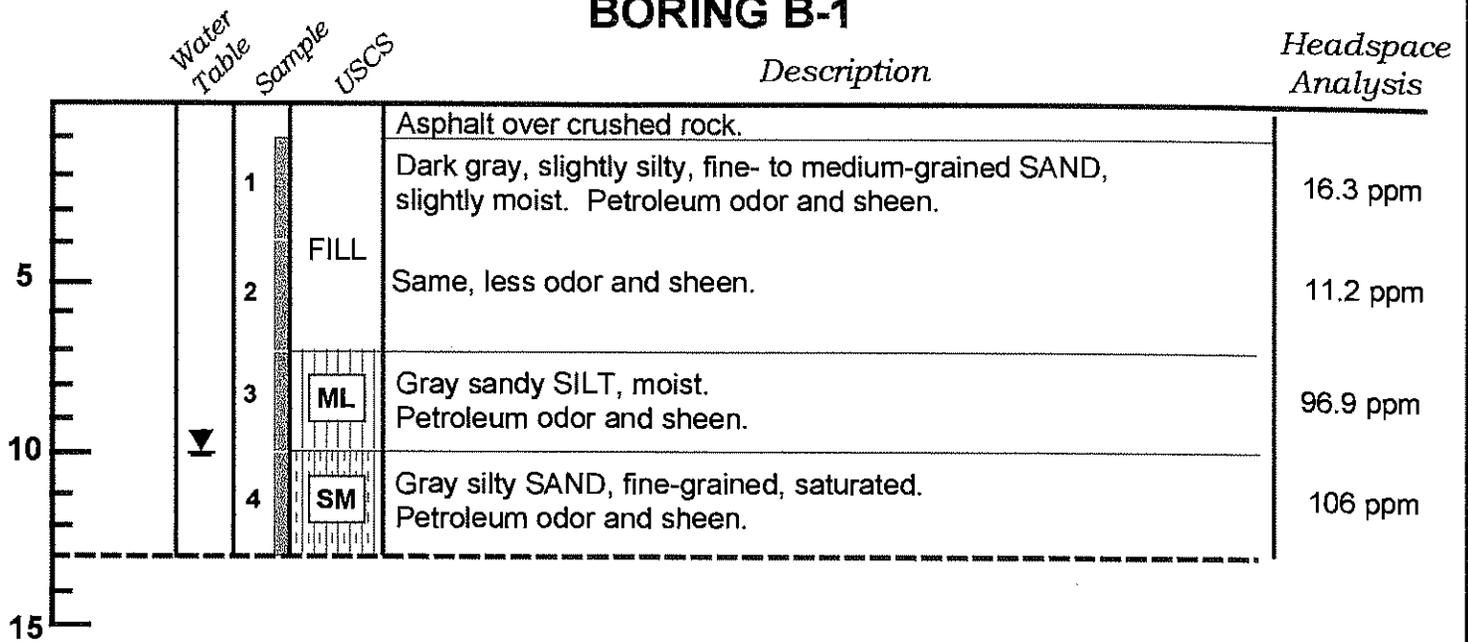
BORING LOG B-1
Maersk Pacific Limited
Building 600
Tacoma, Washington

- * Boring drilled to to 13.0 feet on January 20, 2000.
- * Depth to groundwater (▼) observed during drilling.
- * Headspace measured using a Photovac 2020 photoionization detector.
- * Boring made by Transglobal Environmental Geosciences, Inc.

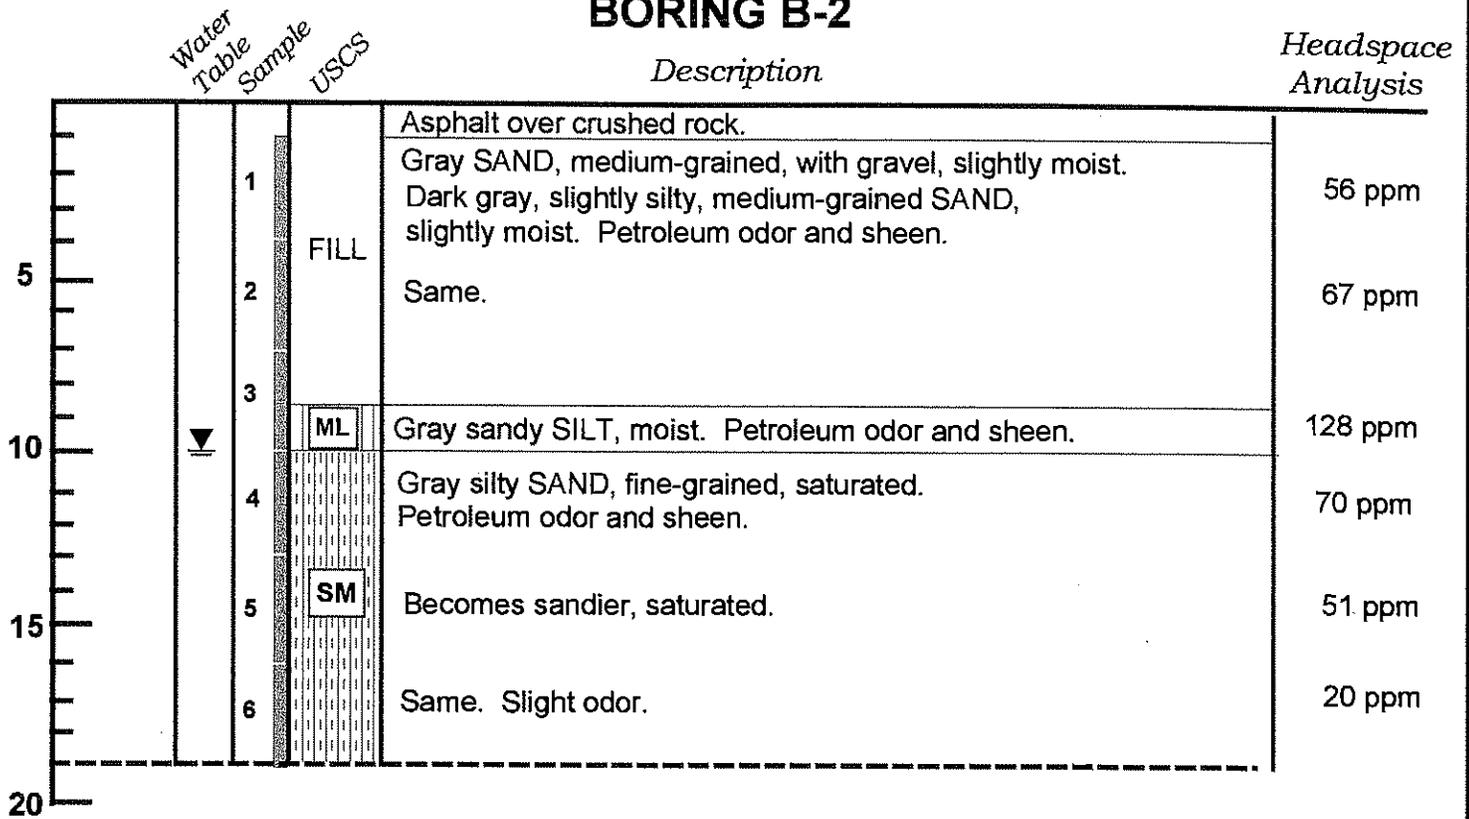
BORING LOG B-2
 Maersk Pacific Limited
 Building 600
 Tacoma, Washington

- * Boring drilled to to 19.0 feet on January 20, 2000.
- * Depth to groundwater (▽) observed during drilling.
- * Headspace measured using a Photovac 2020 photoionization detector.
- * Boring made by Transglobal Environmental Geosciences, Inc.

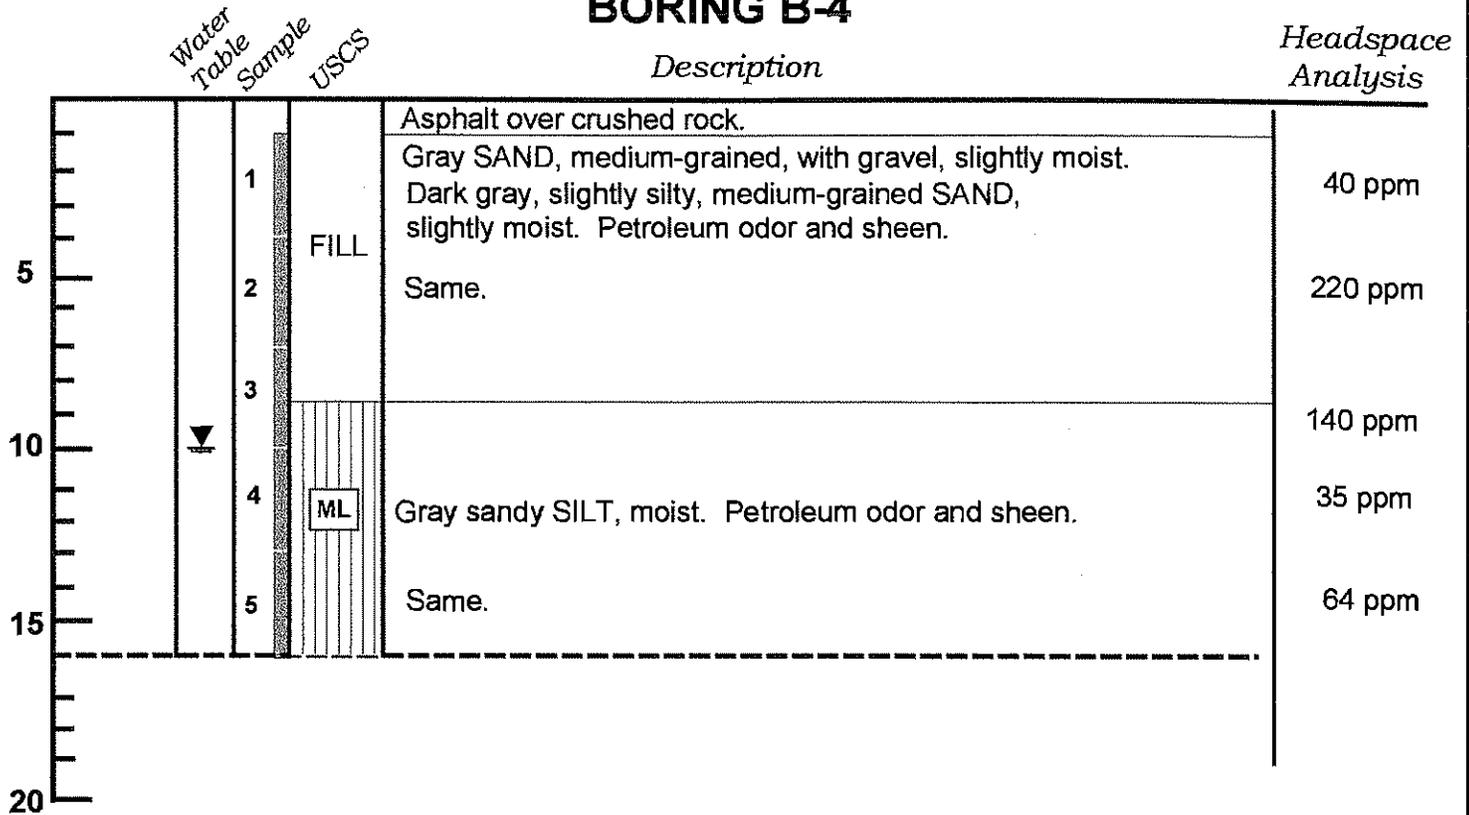
BORING LOG B-4
Maersk Pacific Limited
Building 600
Tacoma, Washington

- * Boring drilled to to 16.0 feet on January 20, 2000.
- * Depth to groundwater (

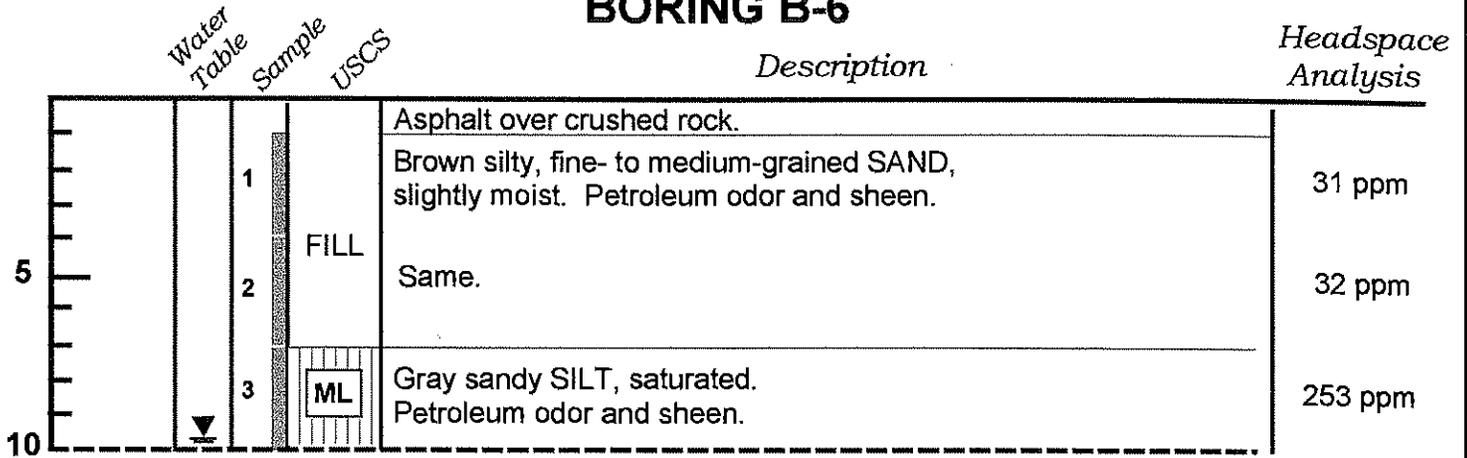
BORING LOG B-6
Maersk Pacific Limited
Building 600
Tacoma, Washington

- * Boring drilled to to 10.0 feet on January 20, 2000.
- * Depth to groundwater (
